LEVEE/BANK STABILIZATION

Along Montana's **Yellowstone**

River

Riprap along the banks of the Yellowstone River in Montana is commonly used to protect properties, but when waters rise, water propelling off these “armored” banks can create damage to downriver banks and levees.

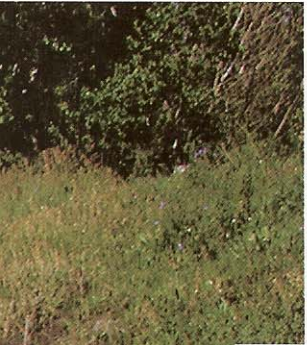
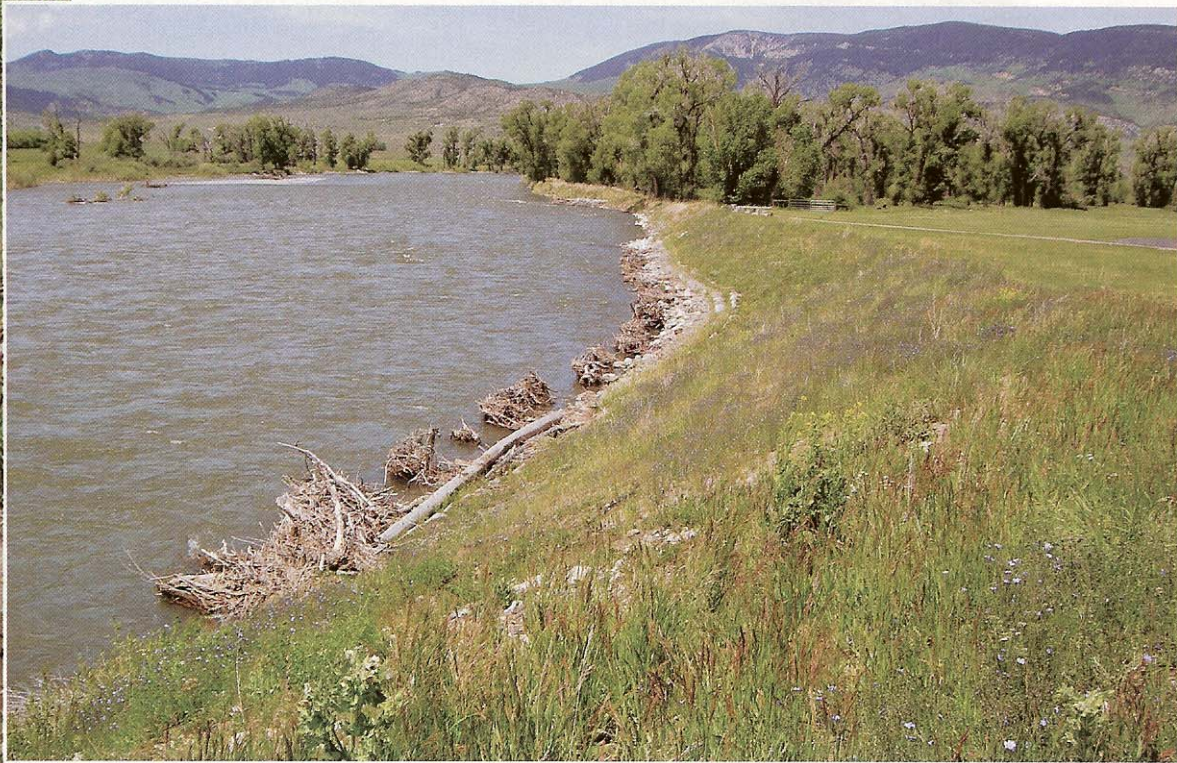
A broad view of the slope (TOP) and a close-up of the riverbank (LEFT) one year after restoration reveal the stabilization of the bank and slope with a combination of deep creek stones consistent with the size of native materials, plant materials and the use of “soft” technology—erosion control blankets (ECBs) and permanent turf reinforcement mats (TRMs). Trout Head Inc. (THI) disdained the more expensive “hard armor” solution of rock riprap, which is less appealing visually, can alter the flow of the waters and create more erosion for downriver banks and slopes.

Installation for Phase II was completed during February 2004. Peak flows on the Yellowstone last year reached 12,200 cubic feet per sec., but THI reports the Phase I and Phase II bank stabilization and restoration treatments have remained intact as the vegetation continues to mature.

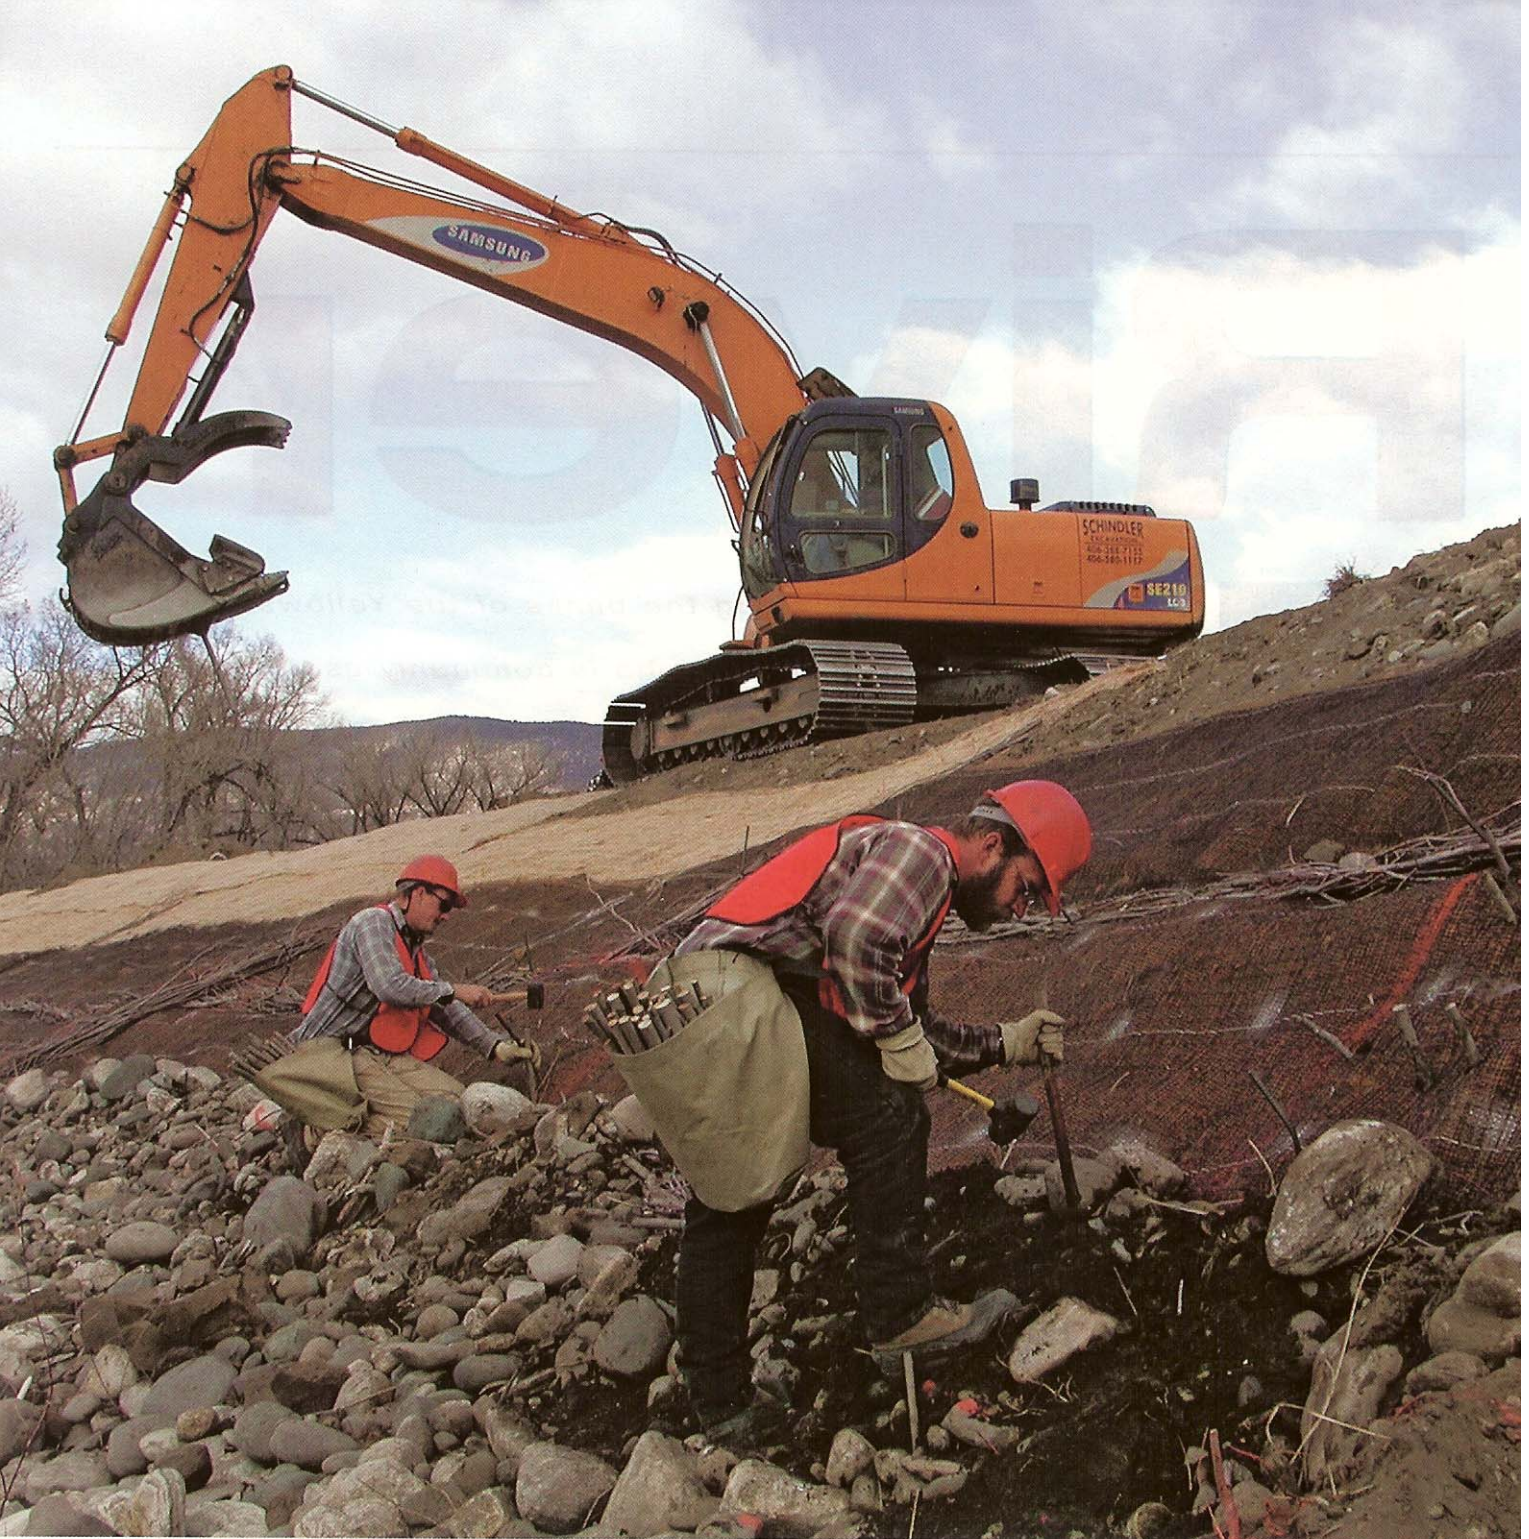
Phase I of the project involved stabilizing a 1,200-foot levee face. Along with dormant plant material THI workers put down 53 rolls of permanent turf reinforcement mat. Here they are anchoring the mats with live willow stakes, willow wattle and fascines. The mats are manufactured with a colored thread stitched along the outer edges as an overlap guide for adjacent mats. Schindler Excavation, Manhattan, Mont., handled the heavy equipment for phase I; Stream Works, Inc., Lincoln, Mont., was the primary heavy equipment contractor for phase II.

Phase I of the project involved stabilizing the levee. THI decided that vegetation along the 1,200-foot levee face would best reduce erosion and not threaten other river

properties. Along with dormant plant material THI put down 53 rolls of permanent turf reinforcement mat, anchored with live willow stakes, willow wattle and fascines. The mats and vegetation treatments worked. However, THI kept an eye out for bank erosion on the property just upriver from the levee. The bank held in 2002, but later that year, as Phase I was completed, an upriver bank stabilization project

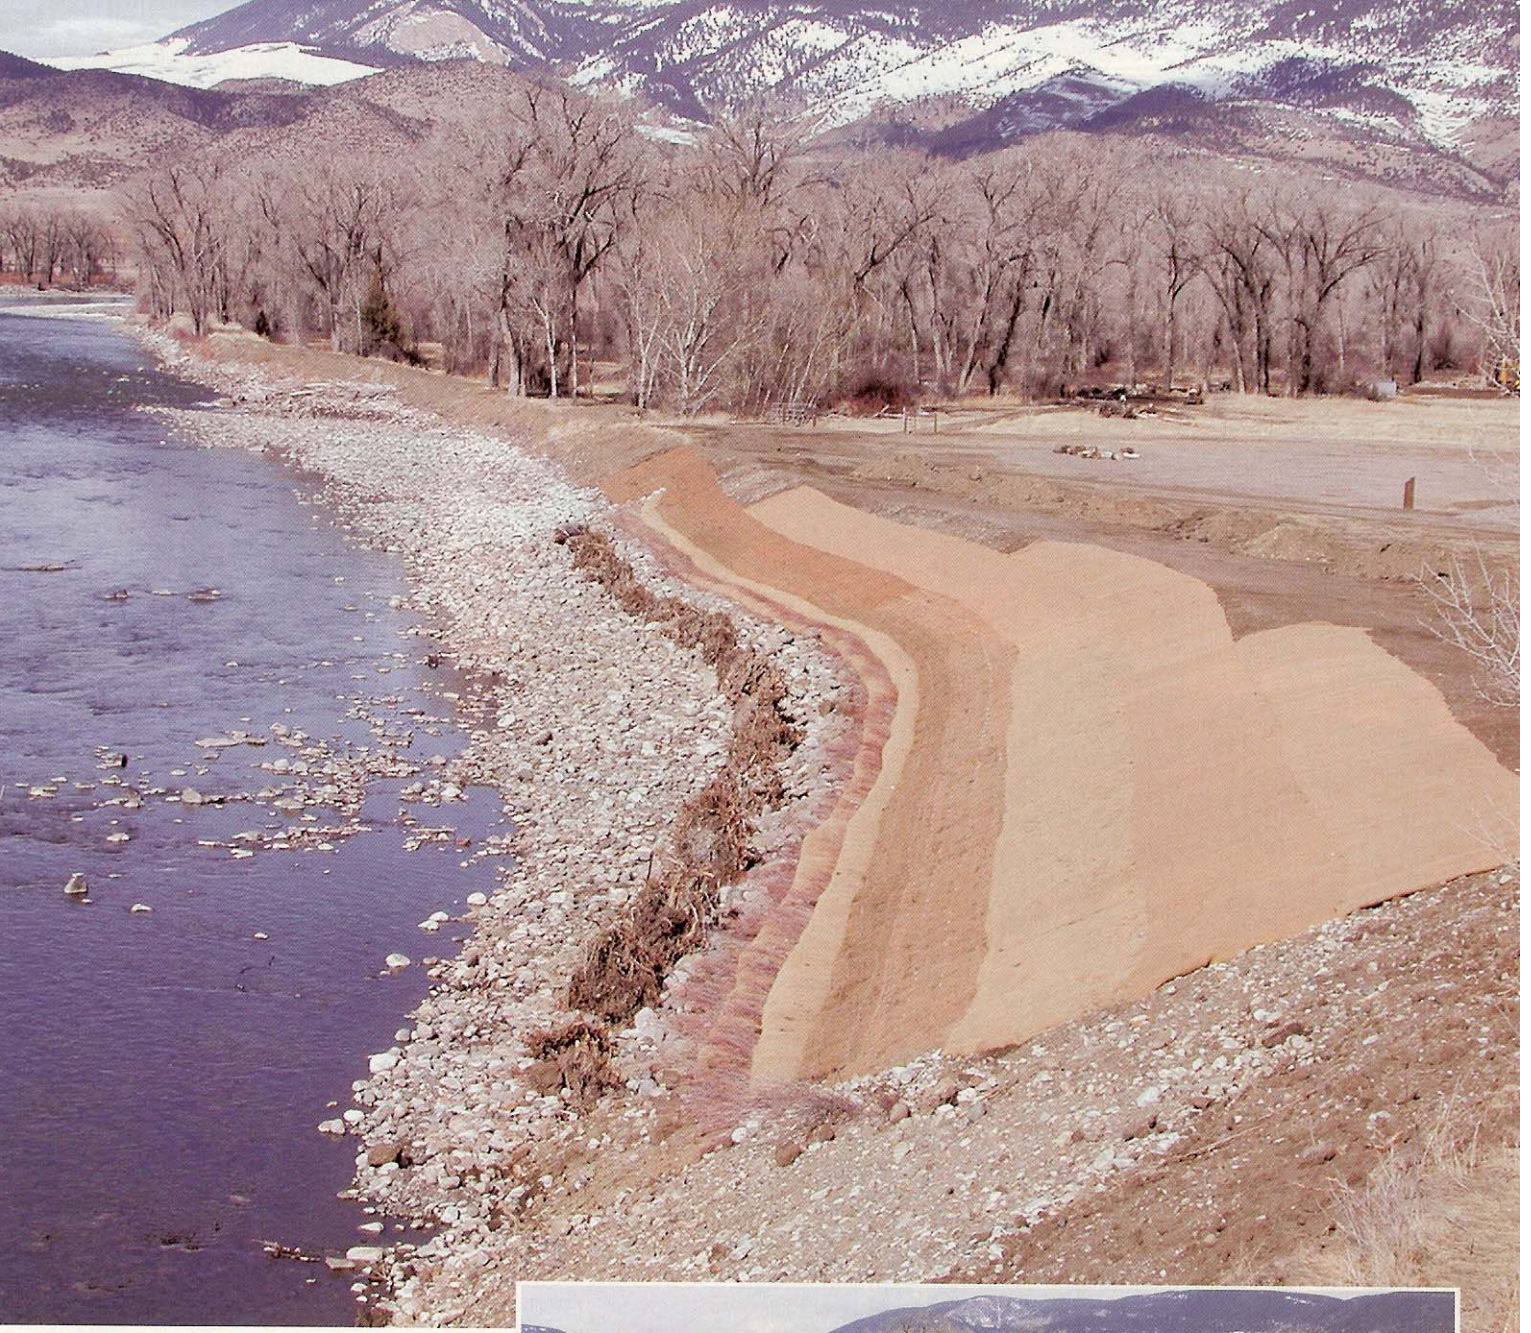
ABOVE: C125 double-net, 100% coconut fiber blankets were installed on the upper slope. These slow-degrading fiber and stabilized nettings blankets provide up to 36 months of protection for slopes exceeding 1:1.

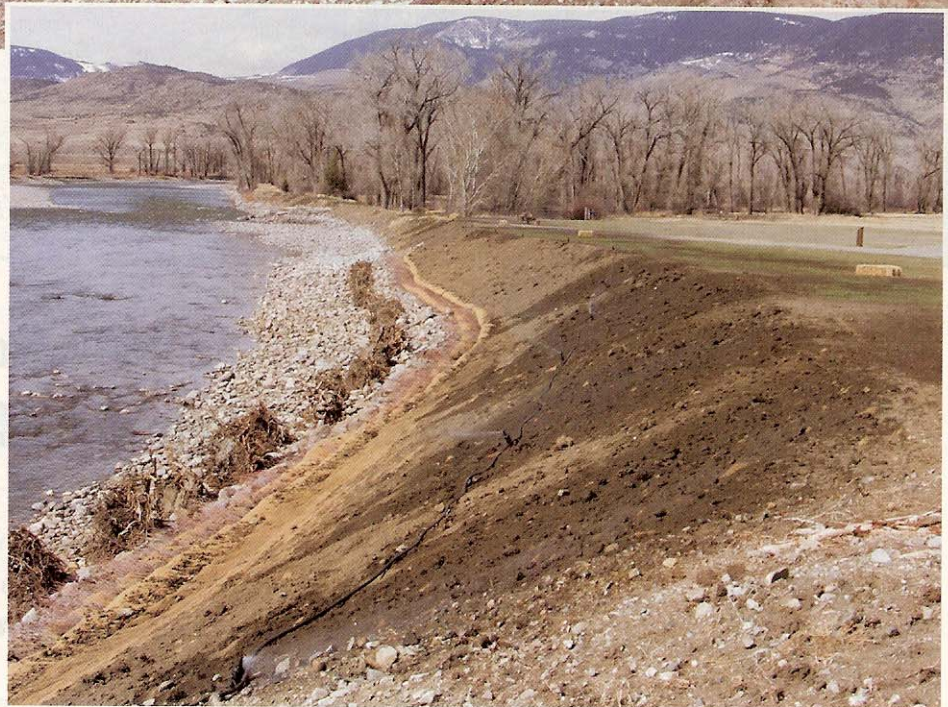
RIGHT: Top soil, a native grass and a forb seed mixture have been added over the slope erosion control blankets. Irrigation lines are in place on the slope.

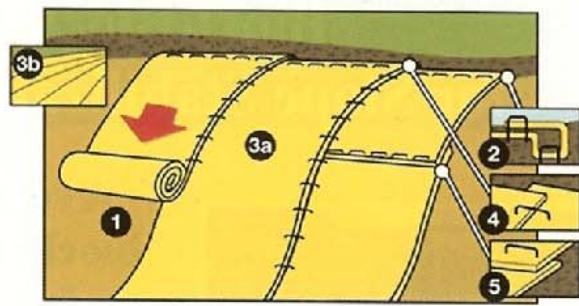
MAT INSTALLATION

- 1 The soil is prepared before installing blankets, including any application of lime, fertilizer and seed. Lime (calcium chloride) is used to stabilize soft subgrades.

- 2 The blanket is anchored at the top of the slope in a 6" deep x 6" wide trench with approximately 12" of blanket extended beyond the up-slope portion of the trench. The blanket is anchored with a row of staples/stakes about 12" apart in the bottom of the trench. The trench is backfilled and compacted after stapling/staking. Seed is applied to the compacted soil and the remaining 12" of blanket is folded over the seed. The blanket is then secured over the compacted soil with a row of staples/stakes spaced approximately 12" apart across the blanket width.

- 3 Blankets can be placed vertical (3a) or horizontal (3b) to the slope. Blankets unroll with appropriate side against the soil surface. All the blankets must be secured to the soil surface by placing staples/stakes (THI uses willow stakes) at the locations indicated on staple pattern guide.

- 4 The edges of parallel blankets must be secured (stapled/staked) with approximately 2"-5" of overlapping blanket.
 - 5 Consecutive blankets spliced down the slope must be placed end over end (shingle style) with an approximate 3" overlap. Staple through overlapped area, approximately 12" apart across entire blanket width.
- Note: In loose soil conditions the use of staple or stake lengths greater than 6" may be necessary to secure erosion control blankets.

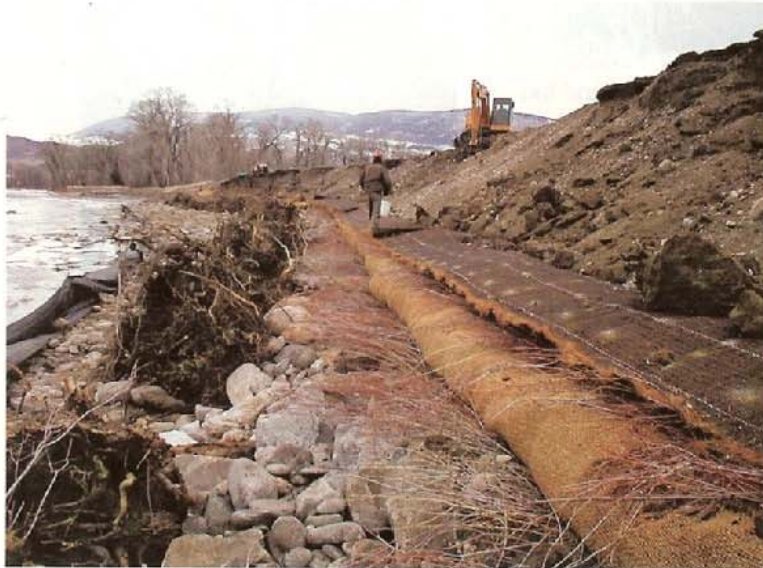
LEFT: The toe of the slope was secured with deep creek stones, consistent with the size of native materials and C350 permanent turf reinforcement mats, 6.5 ft. wide by 55.5 ft. long, covering 40 sq. yards. Coir fiber is evenly distributed across the width of the matting and stitch bonded between three layers of heavy-duty netting, based on one estimate for protecting a 16 ft. x 1,000 ft. drainage channel, 30 inches of rock riprap would cost \$32,000 and \$21,300 in labor, while use of a permanent mat would cost \$7,800-9,900 with labor costs of \$6,400-7,900.

(riprap) directed more water to the monitored bank, which began losing many feet of slope and threatened the owner's home. Phase II kicked in: stabilizing 570 feet of eroding streambank with a combination of rock, blankets and vegetation. Deep creek stones, consistent with the size of native materials, were placed at the toe of the slope. Double-net temporary erosion control blankets of coir fiber and

permanent turf reinforcement mats were anchored with live willow stakes, willow wattle and fascines.

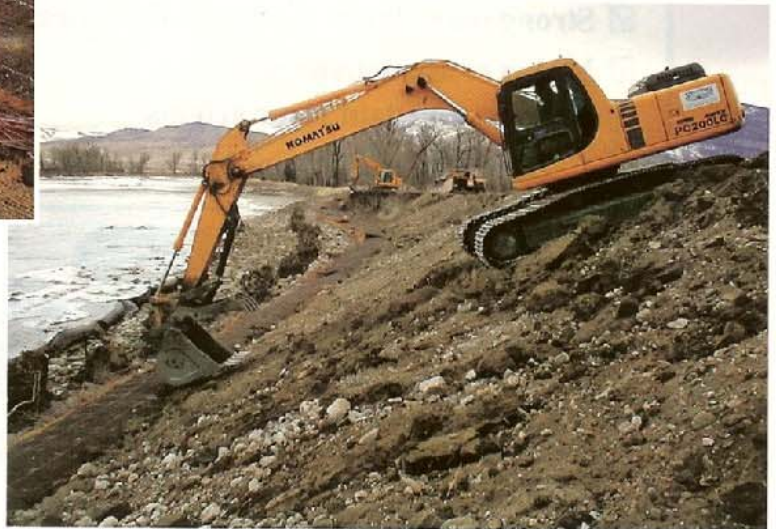
RIGHT: With the toe of the slope secured with stone and permanent turf reinforcement mats, the 46,410 lb. Komatsu PC200LC-7 goes to work to prepare the upper slope for erosion control blanketing by backsloping (lowering) and smoothing the grade. Applications of lime, fertilizer and seed, if required, are applied before the biodegradable blankets are rolled out.
